**GENEVA  
PUBLIC  
LIBRARY  
DISTRICT**

# DETAILED EXISTING BUILDING ASSESSMENT

at the Geneva Public Library

DATE: 10/28/2015

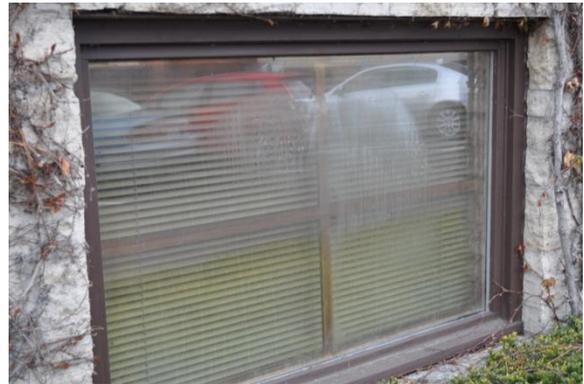
**Windows and Doors:** As with other components in the building, the windows and doors are of varying construction depending on the year that portion of the building was built. The original windows are single pane wood frame windows with storm glass on the exterior. They are significantly past their useful life and experiencing a heavy amount of air infiltration.

This is most notable in the toilet rooms on the main floor where there is not sufficient conditioned air to combat the infiltration this results in freezing temperatures during the winter and the use of temporary heating to keep pipes from freezing. The remaining windows are double pane windows in hollow metal frames. As some of the gaskets in the windows have failed, these windows and doors have also exceeded their useful life and should be budgeted for replacements as soon as possible.

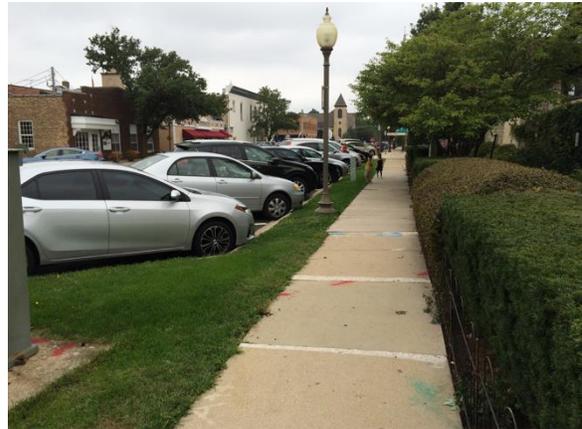
The main entrance to the building is serviced by street side parking. There is one street side handicapped parking space with no accessible curb cut or sidewalk nearby to provide access. This technically is not a compliant space. Patrons confined to a wheelchair must exit their vehicle onto a sloped street and navigate up driveways to access the walks to the library entrance.

Additionally, this parking space does not have the required free zone to allow for compliant loading of a vehicle. It needs to be recognized that if the building were to be built new, the building would require a parking lot of approximately twenty-two spaces and 2 additional spaces would require to be designated handicapped parking. This is far short of the generally accepted amount of parking needed for a facility of this size.

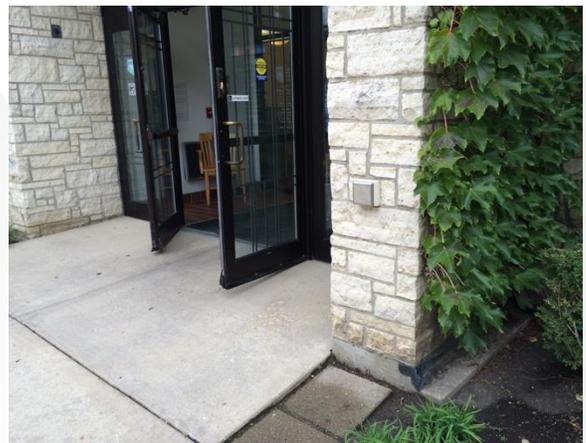
The entrance to the building is at grade with an automatic door operator to allow for access. The operator paddle is located in a spot that only allows a side reach to the unit. This issue is a prime example of where patrons pushing strollers or in walkers do not have a stable location that both provides access to the push button with the ability to quickly and safely enter the building.

These issues are only exacerbated in the snowy winter months as a majority of the access to the building is across walkways that are not the responsibility of the GPLD facilities staff to maintain. All issues noted above are only exacerbated during inclement weather.

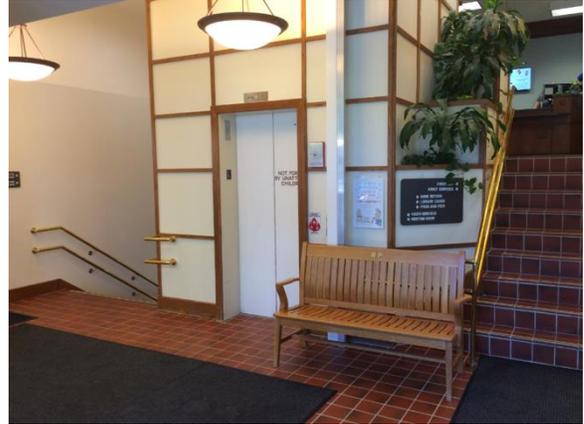
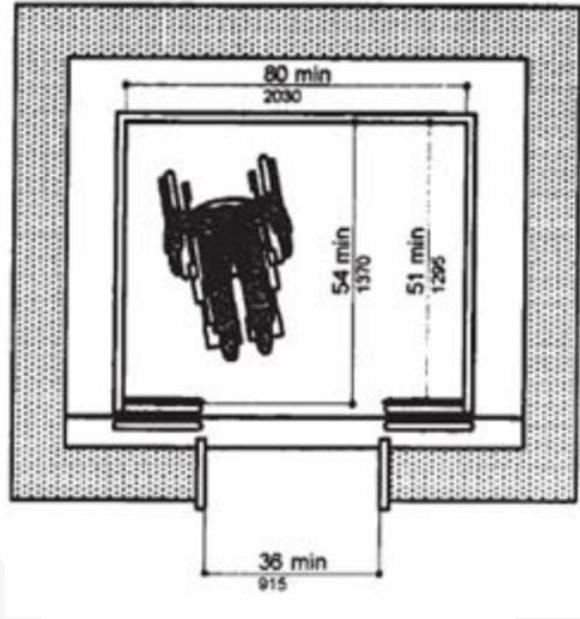
The current elevator does not meet current Illinois Accessibility Code requirements. The elevator opening is less than the 36" minimum requirement and the interior minimum dimension is not compliant as well. In order to become code compliant a full removal and replacement would need to occur with significant impact on the surrounding structure, as well as floor area. This impact on the floor area would have a detrimental impact on library operations.

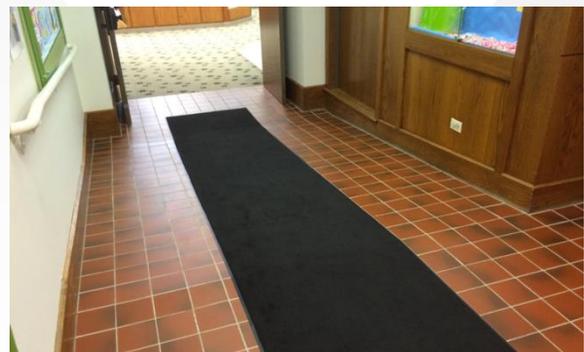
On the lower level there are two ramps that provide access to the children's stacks. These ramps are non-compliant due to excessive slope, as well as lacking handrails. On the primary entrance the ramp is in front of the elevator machine room with inadequate landings at the base; as such a new ramp routing will need to be configured. The secondary ramp will need to be reconfigured as the upper landings do not meet the size requirements nor does the ramp have handrails with proper extensions on both sides of the ramp.

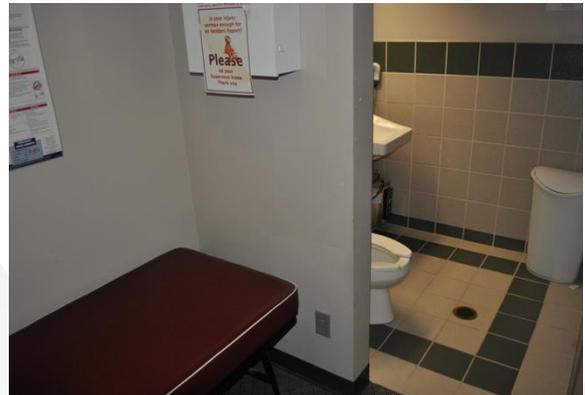
All of the restrooms do not meet minimum ADA compliance for multiple reasons. They vary from in-accessible sinks and clearances within and around the plumbing fixtures. All of the doors to the spaces also do not meet the current compliance requirements. Coupling that with the fixtures and finishes are in excess of their expected life, a total renovation is recommended.
