**GENEVA  
PUBLIC  
LIBRARY  
DISTRICT**

# DETAILED EXISTING BUILDING ASSESSMENT

at the Geneva Public Library

DATE: 10/28/2015

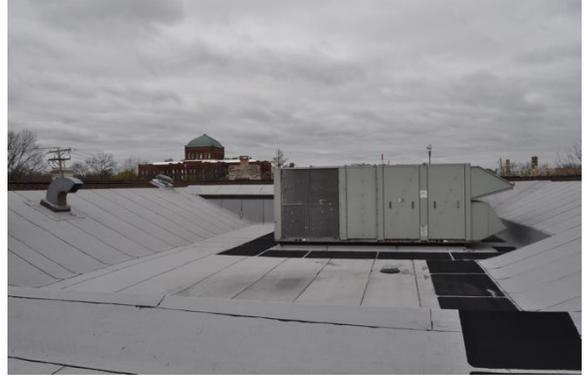
**Roof:** The shingled roof was replaced in 2014 due to a significant number of failures leading to internal water damage. The roof is a combination of a shingle “mansard” roof surrounding a flat modified bitumen roof. The flat roof holds two rooftop units.

The mansard portion of the roof is built from dimensional lumber trusses and it is anticipated (the area was not accessible) that the central flat structure is steel framed and supported to carry the loads of the rooftop units and snow.

As the roof finish has been entirely replaced it is assumed that it will meet or exceed its anticipated life expectancy. Typically for modified bitumen roofs this is approximately 14 years, but should be checked annually after 8 years, and the shingle roof can last upwards of 20 years and should be checked annually after 15 years. It is recommended that GPLD enter into a maintenance agreement with the roofing contractor to provide these services.

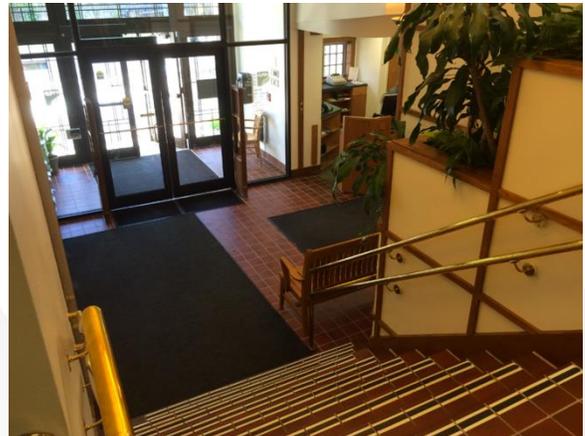
The stairs are adequately located and sized for the use. They are in good condition. GPLD should take care to not allow storage at the bottom of the stairs as this is a building code violation. Please note that any renovation of the front entrance will require the stairs to be reconfigured to be compliant with current codes.

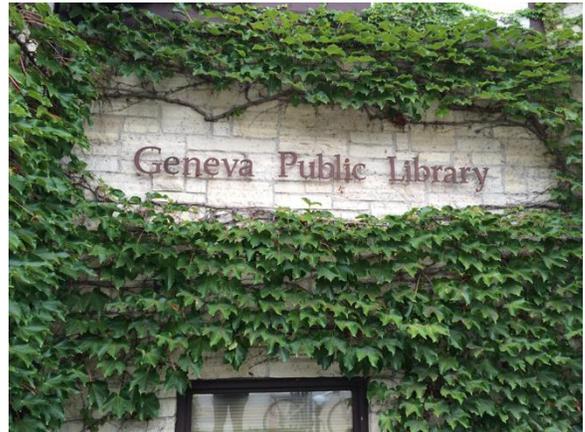
**Energy Efficiency:** The building wall construction is effectively a thermal mass design. Even up until the 1986 expansion and renovation energy efficiency was not a primary concern in building envelope construction. The current wall and window construction allow for air leakage. This is evident in the toilet rooms during the winters when the rooms are frost ridden. This leaves those, and other spaces, vulnerable to freezing and burst pipes.

- *Damp-proof crawlspace below.*
- *Replace windows, doors and frames.*
- *Revise attic to conditioned space per MEP assessment.*
- *Casework refinish and replacement.*
- *Remove all fiberglass blanket and blown-in insulation in attic and provide insulation at roof to create a conditioned above ceiling space where a cold ventilated attic was previously. Provide flooring in above ceiling space to gain access to all VAV boxes for service.*
- *Remove all ivy and overgrowth and repair, or tuck-point, the exterior envelope as necessary.*

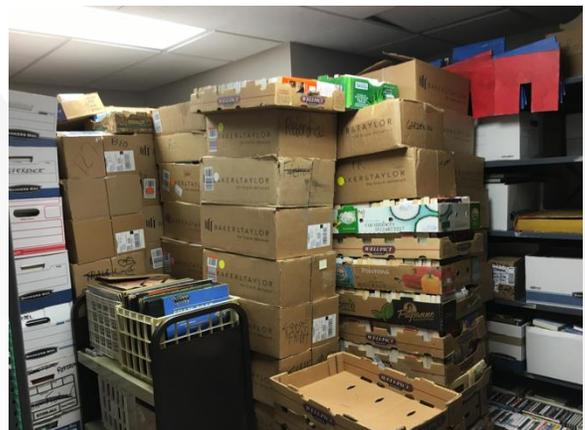
**Building Envelope:** The exterior envelope construction varies in keeping with the age of the additions or renovations. As stated this construction significantly affects the energy efficiency. The ivy growth on the walls of the building and the evidence of air leaks indicates the exterior is in significant need of tuck-pointing and repair. This is also allowing pests to enter into the building, this has been primarily noted in the children’s area (mice in the ceiling) and the bathrooms (box elder infestations).

**Storage Space:** The library has a thriving Friends of the Library group. This has resulted in an extensive need for storage. Prior to the sale events the large meeting rooms storage rooms are filled to capacity. It must be noted that per fire code no storage is allowed within 18” of the ceiling. GPLD currently maintains three off-site storage spaces. It would normally be recommended to find or expand to provide building storage to eliminate the ongoing expense of off-site storage. However, the current location and construction of the

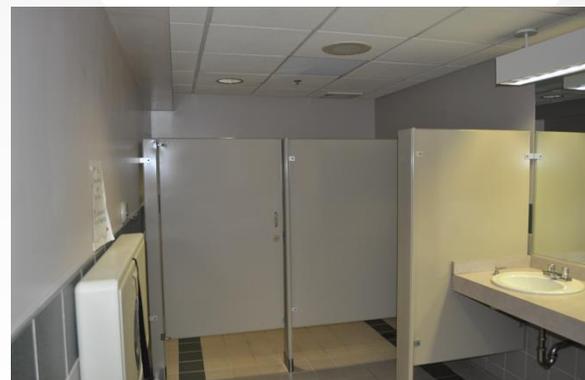
All signage will need to be replaced to meet ADA standards. This would include new visually contrasting type as well as braille components to the signage.

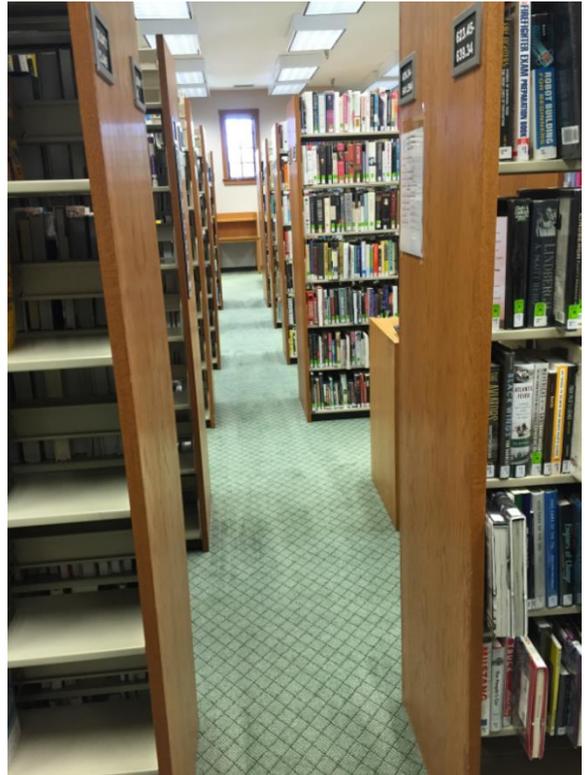
Generally, the shelving and stacks meet the minimum clearance requirements. The issue is with respect to codes that the ends of the aisles need to have a 60" turning radius to allow for proper egress. As such, the recommendation is to modify the current stacks. In some locations the egress width has been reduced to less than 36" due to furniture and other obstructions.

- *Procure additional land for parking.*
- *Designate additional ADA spaces.*
- *Provide accessible route to front of building with sidewalk and concrete repair and replacement.*
- *Removal and replacement of the elevator with additional modifications to building structure.*
- *New ADA ramps with compliant handrails and landings.*
- *Reconfiguration of surrounding space of doors without adequate clearances.*
- *Ramping or accessible route to lower Circulation desk from circulation department.*
- *New ADA accessible toilet rooms in all spaces. This includes the toilet rooms in the children's areas, main floor public restrooms, staff restroom in the rear area, as well as the public restrooms on the lower level. There are no accessible toilets at the entry level.*
- *New ADA compliant signage at all rooms.*
- *Modify existing stack configuration to allow for code required egress.*
